Andriy VASIN, Yuri GOMENIUK, Audrey RUSAVSKY, Alexey N. NAZAROV, V.S. LYSENKO, Petro M. LYTVYN, O.G. GONTAR, Sergii P. STARIK, Corinne NOUVEAU, S. ASHOK - Nano- and micro-scale morphological defects in oxidized a-SiC: H thin films - physica status solidi (c) - Vol. 10, n°4, p.619-623 - 2013

# Nano- and micro-scale morphological defects in oxidized a-SiC:H thin films

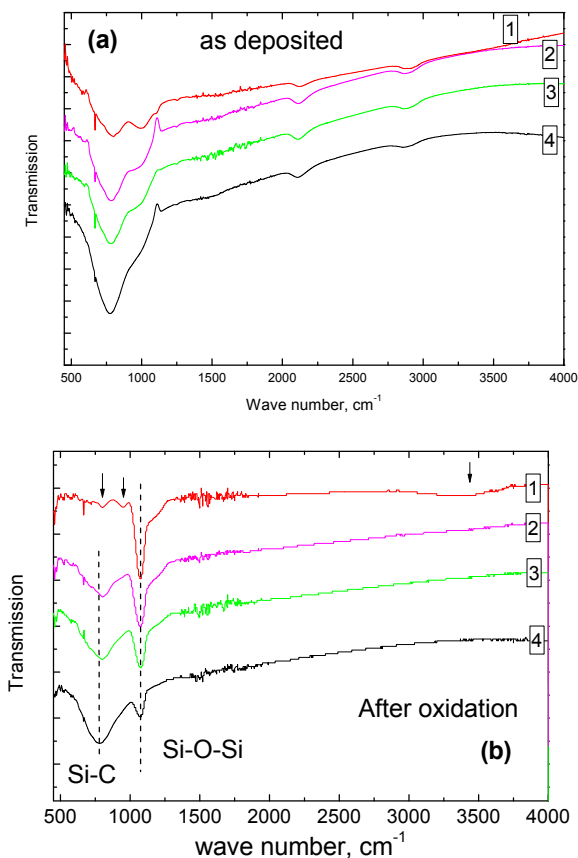
FTIR transmission spectra of as-deposited and thermally treated samples are presented in Fig. 1. Spectra of as-deposited samples (Fig. 1(a)) are composed of four main absorption bands typical for a-SiC:H layers: 800 cm<sup>-1</sup> (Si-C stretching), 1000 cm<sup>-1</sup> (Si-C-H<sub>2</sub> bending), 2100 cm<sup>-1</sup> (Si-H<sub>n</sub> stretching), and 2800–3000 cm<sup>-1</sup> (C-H<sub>n</sub> stretching) [7, 8]. In the 1000–1100 cm<sup>-1</sup> region some contribution to the absorption due to oxygen contamination is expected.

The FTIR spectrum of the sample after oxidation in O<sub>2</sub> atmosphere at 550 °C is presented in Fig. 1(b). No Si-H<sub>n</sub> (2100 cm<sup>-1</sup>) and C-H<sub>n</sub> (2900–3000 cm<sup>-1</sup>) stretching vibration bands were detected after dry oxidation. In the spectrum of the sample deposited at lowest discharge power (i.e. lower density of the material) there are four pronounced absorption bands at 446 cm<sup>-1</sup>, 805 cm<sup>-1</sup>, 945 cm<sup>-1</sup>, 1070 cm<sup>-1</sup> (with shoulder at 1200 cm<sup>-1</sup>) all of which known to be related to oxygen bonds: Si-O-Si (symmetrical stretching), Si-OH (stretching), Si-O-Si (asymmetrical

**Figure 1** FTIR transmission spectra of as-deposited (a) and oxidized (550 °C) a-SiC:H samples deposited at RF-discharge power of 180 W (1), 200 W (2), 250 W (3), and 330 W (4).

It is evident from the figures that the principal effect of increase in discharge power is increase of the relative intensity of the Si-C related absorption band at 800 cm<sup>-1</sup>, in comparison with the hydrogen related band at 1000 cm<sup>-1</sup>. It can be interpreted as increase of the concentration of Si-C bonds and decrease of SiC-H<sub>n</sub> associated mainly with hydrocarbon radicals in the nano-voids. Such interpretation is in good agreement with increase of the density of the films observed with increasing of discharge power.

stretching), and O-H (stretching) respectively. One can see that relative intensity of the main silicon-oxygen absorption bond (1070 cm<sup>-1</sup>) is reduced as the density of the film increases.

In FTIR spectrum of this sample (Fig. 1, spectrum 1) we see only silicon oxide related absorption bands so we can say the a-SiC material is “completely oxidized”. IR absorption cross section of Si-C and Si-O bonds is different but of the same order. From the surface image we see that relative contribution of the volume of island-like regions is quite significant so that we can attribute the absence of the Si-C related absorption in FTIR spectra to the absence of corresponding a-SiC material. Basing on this suggestion we can attribute island-like regions to carbon-enriched highly defective SiO(x) structural fragments.

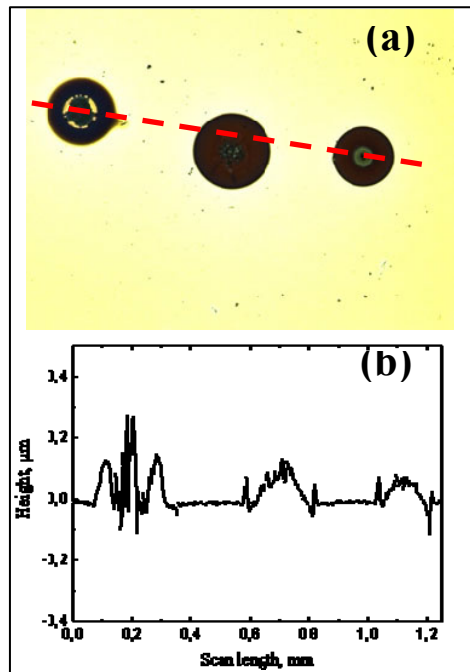
Figure 4(a) shows a typical optical microscopy image of such spots. Optical profilometry showed that these spots are the projections (Fig. 4(b)) with a complex structure of the edge and the center. Usually these defects are formed around pin-holes or near the edges of the silicon substrate.

**Figure 4** Optical microscopy image of the micro-defects (a) and corresponding surface profile (b).

When measuring the profile of the distribution of elements, the ion etching conditions were identical so the delayed arrival to a silicon substrate in the case of measurement over the dark spot is obviously due to the greater thickness in this location, which is consistent with optical profilometry data (see Fig. 4(b)).

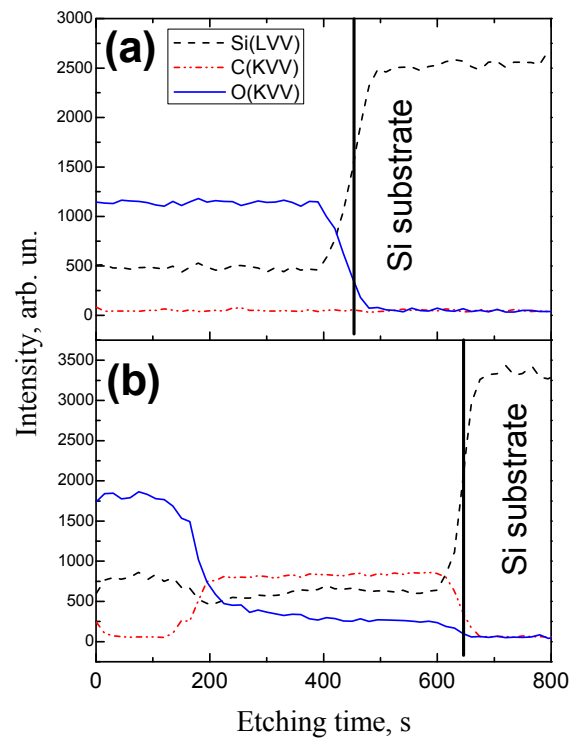
Nano-probe Auger electron profiles of silicon, carbon and oxygen in the dark spot and in the open surface are shown in Fig. 5. It can be seen that in a homogeneous area of the film the distribution of the elements in depth of the film is homogeneous and corresponds to amorphous silica.

In the dark spot the profile of the composition is represented by two areas: (1) the upper area with a high concentration of oxygen, and (2) the lower area, with high carbon content. The oxygen concentration drops at the boundary and then slowly decreases toward the silicon substrate. The silicon concentration in these two areas differs little. Thus we can conclude that dark spots are represented by a bi-layer: upper layer of silicon oxide and underlying nano-composite layer composed of amorphous silicon carbide and amorphous carbon precipitates.

**Figure 5** AES depth profile of the distribution of silicon, carbon and oxygen in the region of uniform surface (a) and “dark hole” defect (b).
